Proceedings of the SHATIS 2025 – 7th International Conference on Structural Health Assessment of Timber Structures

3rd – 6th September 2025, Zagreb, Croatia

International Conference on Structural Health Assessment of Timber Structures

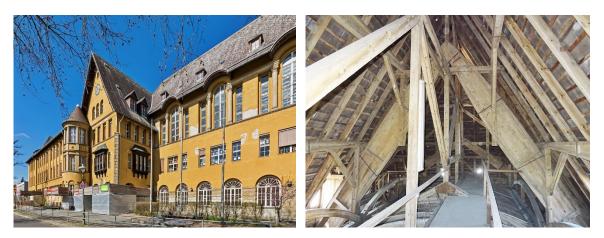
Figure 4. Fichtenberg High School, Berlin/Germany - left: exterior view; right: interior view of the roof construction

In addition to the investigations described above, the strength grading methodology was applied in comparative material test on sample material from historical, partially deconstructed timber structures (see [16, 17] and Figures 4 & 5). In the course of this, it was determined that minor adjustments to the methodology are necessary regarding the consideration of the load-bearing capacity-reducing growth and component characteristics.

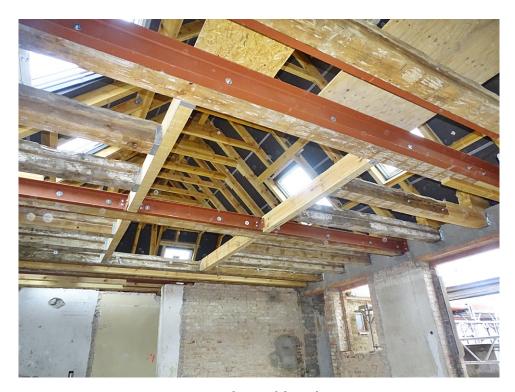
Figure 7. Examined part of the ceiling structure

The focus of the field study was on the timber beams of the ceiling above the second storey since extensive redevelopment measurements – including the replacement and reinforcement of individual beams – have been carried out. The roof construction was not considered in this field study since the structure was completely replaced due to extensive biological damage.

The assessment of the material quality revealed that significant load-bearing reserves were present. Both strength grading level SGL 2a and SGL 3 resulted in an allocation of the floor beams to the strength class C40 according to EN 338 [13]. The solemn visual grading of the floor beams according to DIN 4074-1 [10] – which is comparable to strength grading level SGL 1 (see Figure 1) – resulted in the allocation to the strength class C24 according to EN 338 [13]. Based on the mechanical properties given in EN 338 [13], the apparatus-supported strength grading revealed load-bearing reserves in the range of 67 % concerning the flexural strength, respectively 27 % concerning the modulus of elasticity. Such reserves can be used to minimise the redevelopment measures, particularly the material usage.

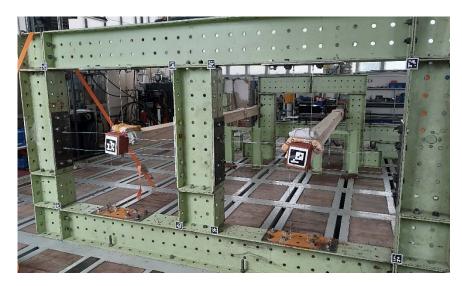
Figure 1. Beams in the testing hall equipped with ArUco markers [6] for precise displacement monitoring.

Two logs were prepared from Norway spruce with nominal cross-sectional dimensions of  $12 \times 14$  cm and a length of 400 cm. Each log was installed in a test rig with one end rigidly fixed, effectively eliminating all degrees of freedom to prevent any movement or rotation. The opposite end was secured using eight galvanised steel wires, each with a diameter of 2 mm, arranged in a pre-defined configuration as shown in Figure 1. This setup enabled the transfer of any torsional or longitudinal forces generated during drying into measurable tension in the wires, facilitating quantification of the internal loads induced by shrinkage and spiral grain effects. The logs were monitored throughout the drying process, beginning from the fibre saturation point (green wood condition) down to a target moisture content (MC) of 12%. The experiment was conducted in a controlled indoor testing hall, where the average temperature was maintained at approximately 23 °C, and the relative humidity remained stable at around 50%. These environmental conditions were chosen to simulate standard indoor drying scenarios and ensure consistent moisture loss across the duration of the test.

Monitoring of the displacements was carried out using optical measurement techniques [6], as well as through the analysis of vibrations in the steel wires. The recorded signals were processed using Fast Fourier Transform (FFT) to determine the eigenfrequencies, enabling indirect estimation of the forces generated during the drying process. The implementation was done using NumPy/ScipPy libraries [5].

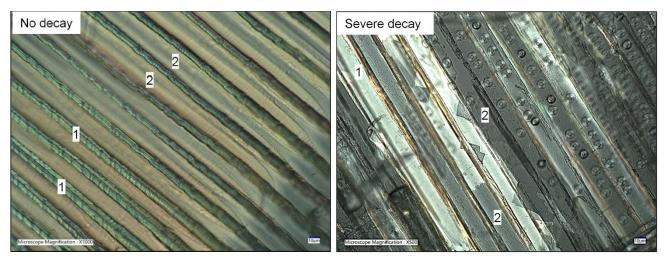
Figure 6. Left: Representative example of a slice with no decay based on the adopted classification. Smooth cell walls are present (1), showing bright colours because of intensive birefringence; erosion channels are absent and smooth walls are also observable within the cell lumen (2).

Right: Representative example of a slice with severe decay based on the adopted classification. Isolated sound cells (1) still showing birefringence and brighter colour are present, within a matrix of degraded cells (2), showing no birefringence. Presence of V-shaped notches in the few remaining partly sound cell walls can also be observed.

More recent images have been obtained directly from retrieved piles from Amsterdam foundations, where light microscopy was used to observe birefringence as an indication of decay (see Figure 6), and density measurement using CT-Scanning (see Figure 7).

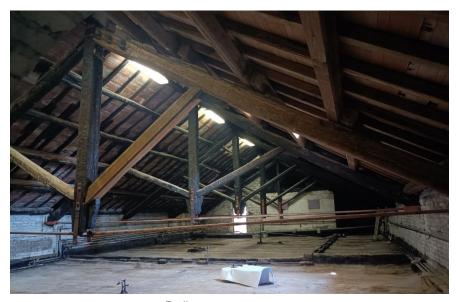
Figure 1. Truss selected for the study with marked test sections.

The object of study was taken as the component elements of three of the eleven trusses that form the roof structure, and six purlins, in a historic building located in Rome, built at the end of the nineteenth century (Figure 1).

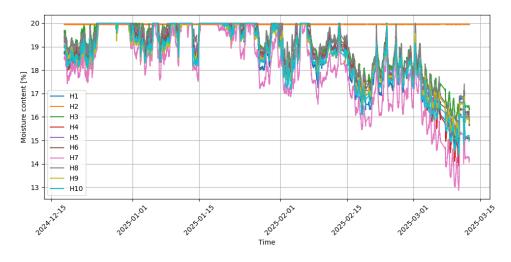
Figure 7. Moisture content at the roof

The moisture content on the roof has been measured at 10 locations. These results are visualised in Figure 7. Here, it can be seen that for H2, which has been placed in the mould, the moisture content remains constant around 20% (the upper limit of the sensor). For the other humidity sensors, it can be seen that these sometimes also reach the 20% limit, linked to very wet outdoor conditions (snow/rain). In general, with spring approaching at the time of analysing these data (March 2025), the sensors also indicate the drying of the structure, with local fluctuations related to daily temperature changes. The relationship between the outdoor environment and the moisture content of the timber is also visualised

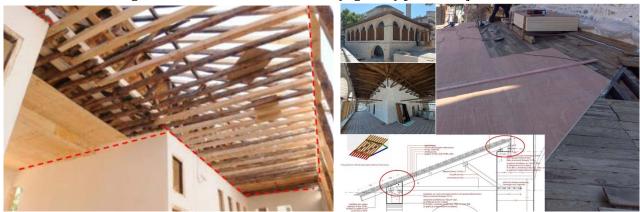
Figure 3: a) Benizelos mansion in Athens. Application of 20mm plywood over the ceiling, with both layers screwed onto the ceiling beams of the roof (horizontal plane) [8]. b) Kaloutsiani Mosque in Ioannina. Application of plywood over the interior visible timber planks. The inclined timber diaphragm, anchored to the masonry walls through timber-tie beams (red circles), was used to enhance the seismic resistance of the angular porch, especially against out-of-plane forces [9].

• Timber applied through various methods (planks and plywood), to improve the diaphragmatic action of existing or new timber roofs and floors (Figure 3) [8,9,10,11].

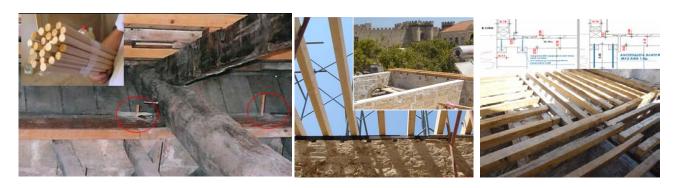
Figure 5: Hagi Mehmet Aga Mosque in Rhodes. a) Timber dowels (d=14mm) were used instead of steel dowels to connect the timber lacings to the masonry beneath, since steel dowels had often caused significant damage to the porous stones of Rhodes. Benizelos Mansion in Athens and the Turkish mansion in Rhodes [11]. b) In these cases, the usual cross timbers of the lacing system—normally placed above the longitudinal elements— were instead embedded within the masonry beneath the longitudinal timbers and connected to each other with screws (d=8mm) [8,12]. c) Timber floor beams screwed onto timber lacings anchored into masonry with stainless rods [11].

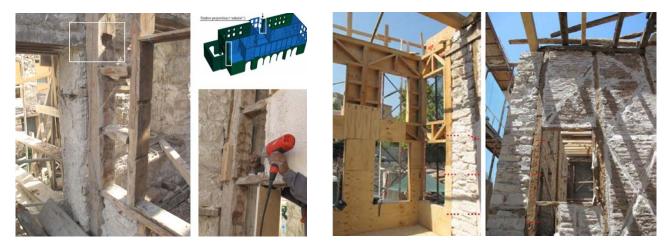
Figure 7: Benizelos Mansion in Athens. Connection with screws of the last post of the load bearing timber-framed walls of the building to the tie beams along the height of the masonry walls, using carbon steel screws (system WT) [8].

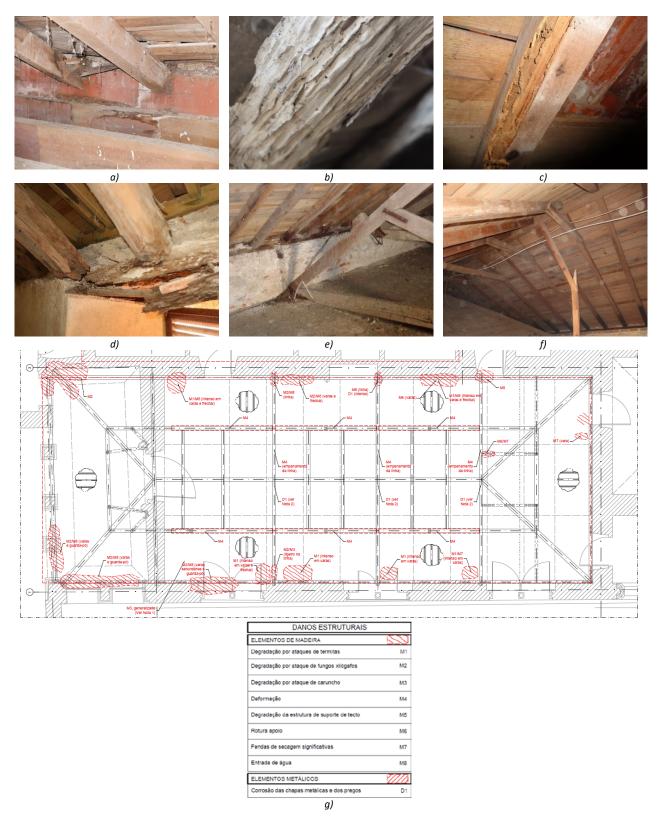
Figure 5. Example of the main damages identified during the structural assessment (a, b, c, d, e and f) and the mapping of damages carried out on the structural plan of each of the roofs (g)

The main damages observed are related to the attack of biotic agents, especially fungi (Fig. 5a), woodworms (anobiids) (Fig. 5b), and social insects (termites) (Fig. 5c). As a consequence of this attack,

material degradation of the structural elements is visible, which is significant in areas of high-water moisture content and in the oldest structural elements, which have been exposed for a long time to the attack of these agents. The intense material degradation caused, in some cases, deformation and even rupture of the structural elements (Fig. 5d, 5e and 5f).

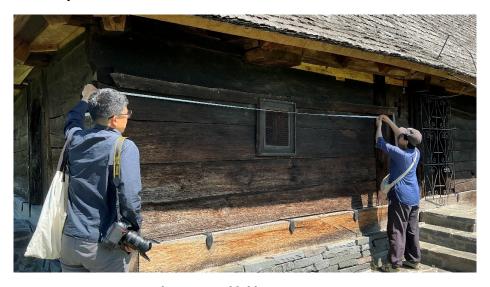
Figure 1. The picture of field measurement activities

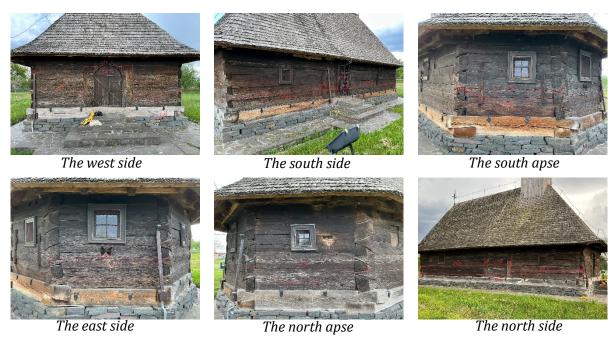
Figure 2. The pictures, when measured

All four sides were measured, and the dimensions were directly annotated onto the photographs. Drawings reflecting distortions were created from the 3D model, while details such as member positions and joints were recorded onto the drawings based on the field measurements.

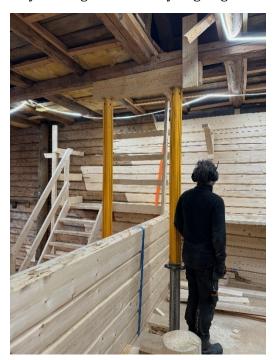
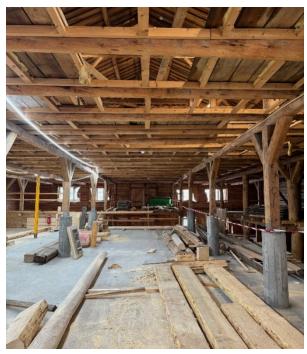
Figure 2. Brygge 15 during adaptation: replacement of rotten timber (left), concrete structure from the 1980s.

One of the buildings recently adapted for reuse, Brygga 15, shown in Figure 1, is from 1857 but has undergone renovation in the 1980s, Figure 2, when the inner timber structure on four stories was replaced with concrete, causing the timber flanks on all sides to deviate from horizontal position over time [1]. Thus, in the current adaptation, reinforcement of the roof structure was introduced. Brygge 15 is depicted from the riverfront in Figure 1 (left), and the top floor with roof frames before and after the adaptation is shown (centre and right). As many similar existing timber buildings will require renovation and adaptation, and their historical character and value are of importance, the assessment of the mechanical properties of the original timber is necessary. Some of the timber specimens can be acquired for testing, but the logistical, labour and laboratory costs are high. Thus, a campaign of different non-destructive and destructive tests was performed on the timber acquired from one wharf. A visual strength grading standard [1] has been recently released in Norway to support the effort toward timber upcycling and resource conservation. Among other proposals for grading [2]. Nevertheless, the current standardisation framework does not facilitate the reuse of recovered wood [3], even though its technical feasibility is being confirmed by ongoing research [4].

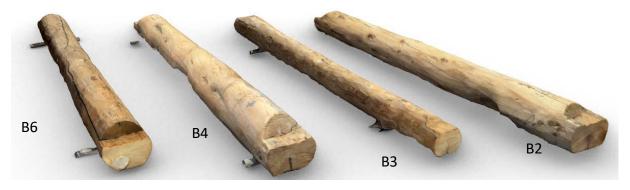
Figure 3. LIDAR scans of specimens B2, B3, B4, and B6 tested in the laboratory and recovered from Brygge 15, Trondheim

Timber pieces of Norway spruce (*Picea abies* (L.) Karst.) were salvaged from the wharf and transported to the laboratory for a non-destructive testing (NDT) campaign followed by a destructive four-point bending test according to the European standard EN408 [5]. In total, four laboratory-tested roof specimens, see Figure 3, and three field-tested roof specimens, see Figure 4, were analysed in this work.

Timber beams were scanned with LIDAR to store geometry data and visual characteristics for further analysis and to assess cross-sectional dimensions more accurately for stiffness and strength estimation. See examples of scans in Figure 3. NDT included: ultrasound pulse velocity (UPV) (Pundit Lab 200, Proceq), acoustic stress wave time (Microsecond Timer - MST, Fakopp, Bt), local density (Resistograph, Rinntech), moisture content (Lignometer, Lignomat), and acoustic stress wave resonance (Resonance Lumber Grader, Fakopp Bt.).

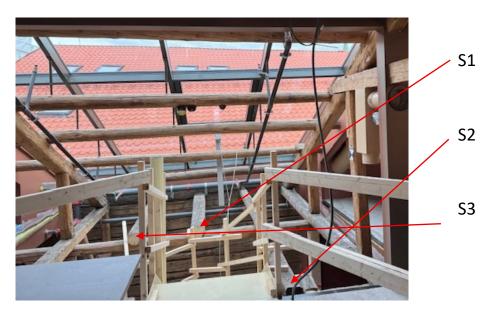
Figure 4. Specimens S1, S2, S3 measured in situ after adaptation (renovation), Brygge 15, Trondheim

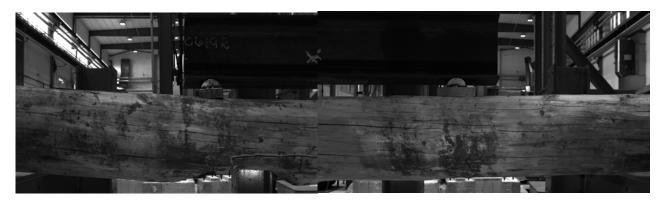
Figure 5. Set-up for destructive four-point bending test with typical failure in bending: fibre splitting.

Destructive testing was carried out following EN408 [5] with a four-point under static load conditions, see Figure 5. Force-displacement curves were obtained with displacement at the load cell position. The formula for the modulus of elasticity was modified to account for that using the following equation (3):

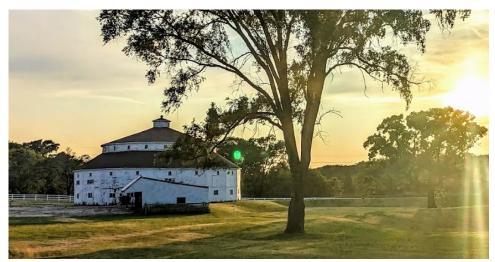
Figure 1. The 30.48m (100ft) diameter Manhattan Round Barn [photo C. Bill Thorpe, 2024].

This barn is situated at the top of a floodplain, resting on the remnants of an ancient glacial lake. The original foundation consisted of solid, hard local limestone; however, the building was set at grade, resulting in significant damage to the wood materials in the lower sections. Due to the type of plank-on-plank construction for the lower walls, they acted like sponges, absorbing water. This eventually led to

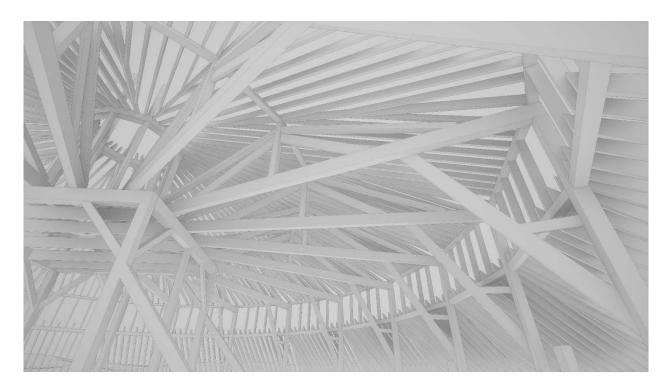
Figures 4 and 5. A rendering at the top, and a typical bent section.

Due to future needs, code requirements, and budget, the original lower wall, which was nail-laminated plank-on-plank, was not rebuilt. A new stud-style  $2" \times 6"$  platform wall is being constructed to replace the plank-on-plank wall. This new wall will be reinforced with plywood to increase its shear strength and will be anchored securely to the existing foundation with embedded anchors. The previous structure lacked any hold-downs for wind; the region is prone to high winds and tornadoes.

The new plywood layer will also serve to connect the first and second floors, allowing for the reinstallation of new white pine shiplap siding, which will match the original historic aesthetic of the barn. Internally, all original posts will be removed and reinstalled on new footings. The second-floor deck will be reinforced with an additional joist to meet the increased load requirement of 100 pounds per square foot (4788 pascals). Additionally, truss work will be implemented at the third level to further increase the building's capacity to handle snow and wind loads.

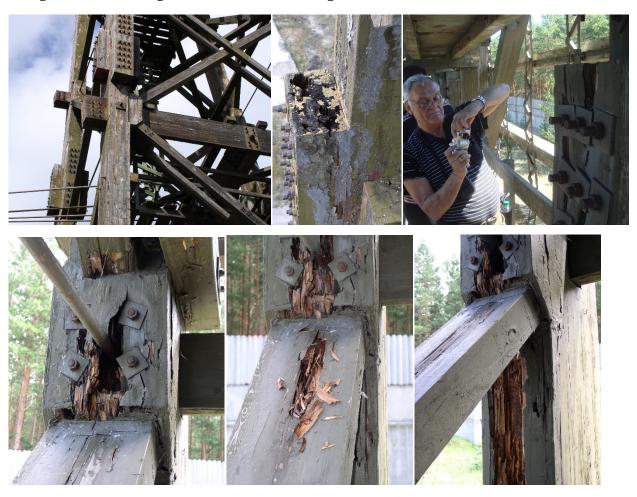
Figure 3. Cracks in structural elements and nodes during inspection in 2011

an electric shock. The elements with cracks remain the most vulnerable in terms of the electrical strength of the insulating structures, as shown in Fig. 3.

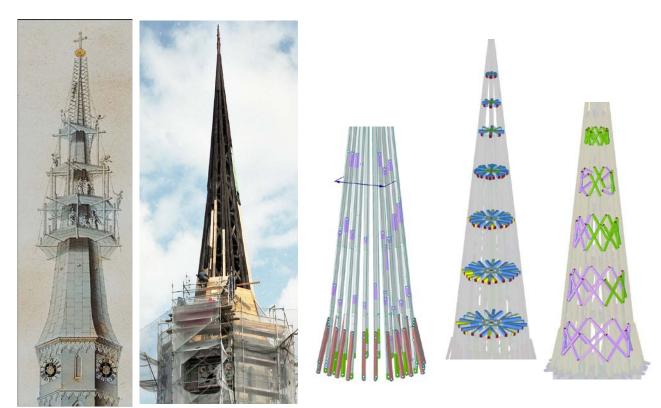
a) Repair in 1825 and 2000

b) Repair of rafters (l), radial beams (m) and diagonals (r)

Figure 5. Numerous repairs over centuries

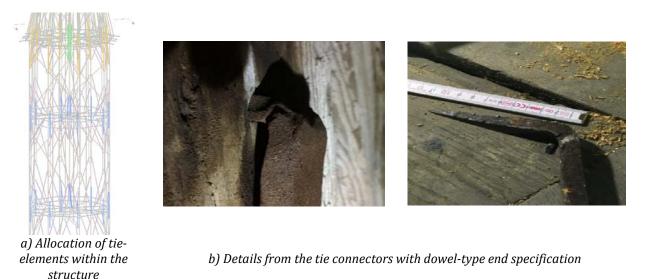
Figure 9. Initial concept of a tie-connection to prevent rocking

As a matter of prevention, each continuous angle rafter has been connected to the vertical column below according to Fig. 9a. The dowel-type ends of such tie-elements, according to Fig. 9b, are slightly inclined to induce the effect of pretension while being pushed into the timber matrix. Barbs should ensure stable fixation. The absence of embedment deformations indicates that this anchorage system has never been activated, even during heavy storm events.

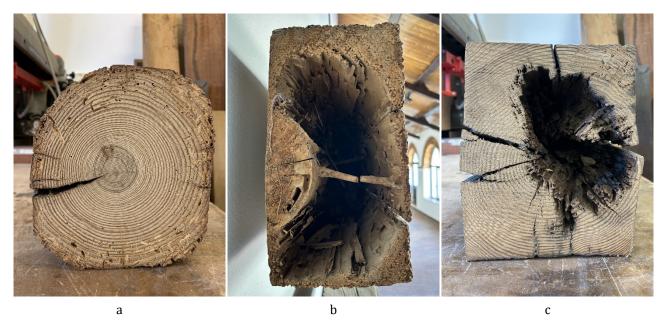
Figure 22. Different types of biotic decay in wooden beams (a) galleries and exit holes of anobiid and cerambycid beetles in the outer part, corresponding to the sapwood; (b) termite damage affecting almost the entire cross-section, except for the outer layer, the knots, and the pith; (c) fungal decay affecting the inner part.

Biotic degradation in timber structures is caused by biological agents such as insects and fungi [5]. Among the most common wood-boring insects affecting historic architectural elements are Anobiidae, Cerambycidae, and termites. In the case of anobids and cerambycids, their presence is often revealed by small exit holes and fine frass deposits. Insect attack is often perceived as the main threat to timber structures, but its structural impact is frequently overestimated [6], especially when the infestation is superficial (Figure 1a). In many cases, deterioration progresses slowly and may remain inactive for extended periods unless environmental conditions favour insect development. More concerning is termite infestation, whose destructive capacity can indeed be severe. Unlike other wood-boring insects, termites can cause extensive internal damage while leaving few visible signs on the surface, making early detection challenging (Figure 1b). Their colonies can remain active for years, progressively compromising the structural integrity of timber elements, especially in warm and humid climates. In most cases, fungi are the principal agents of wood deterioration [7]. Wood-decay fungi, including brown rot, white rot, and soft rot species, require high wood moisture content to grow and are generally more widespread and structurally damaging than insect infestations, though they are often less apparent in their early stages (Figure 1c). Poor ventilation, high relative humidity, and prolonged moisture exposure create ideal conditions for fungal attack, making this form of biotic degradation particularly insidious in historic timber structures. Fungal attack typically occurs in areas where moisture accumulates, particularly at interfaces between timber and other materials or in poorly ventilated zones where water tends to become trapped. The hygroscopic nature of wood, which allows it to absorb and release moisture from the surrounding environment, makes it vulnerable in such conditions, especially when exposed to condensation, infiltration, or capillary rise.

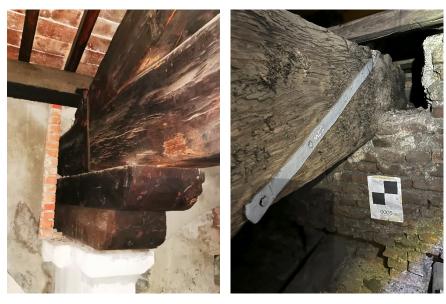
Figure 23. Examples of enlarged masonry pockets at the truss ends

In the context of historic timber structures, several traditional construction details emerge as key strategies for mitigating degradation risks, particularly those aimed at controlling moisture accumulation around wooden elements. Among the simplest and most common solutions were ventilated masonry pocket details, which allowed air circulation around structural elements, helping to keep moisture levels below the threshold for fungal growth. As shown in Figure 2, especially when the structure is not exposed, the pocket where the truss rests within the wall is enlarged to minimise the contact surfaces between the timber and the masonry. This configuration helps prevent moisture

accumulation and promotes air circulation around the embedded timber element. This simple strategy not only contributes to risk mitigation but also facilitates inspection of the structural area most vulnerable to deterioration.

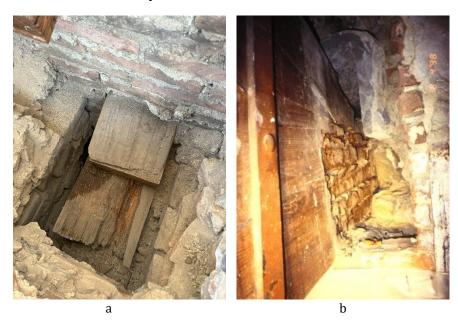
Figure 24. (a) Ventilated cavity in the masonry; (b) Inverted C-shaped stone above the rafter and the fungal decay on the tie beam end

When the roof structure is exposed, for aesthetic reasons, the masonry pocket where the truss rests is often in direct contact with the timber elements. In some cases, to mitigate the risk, the adopted solution was to create a ventilated cavity within the masonry, in contact with the outside through small ventilation holes (Figure 3a). Otherwise, the portion of timber in contact with the masonry is susceptible to deterioration phenomena, such as those visible in Figure 3b. In this example, water infiltration through the roof covering created the conditions for fungal attack. When the masonry surrounding the end of the truss was opened for a detailed inspection, an area with visible fungal decay on the tie beam end was found, along with a particular inverted C-shaped stone element positioned above the rafter to prevent direct contact with the masonry.

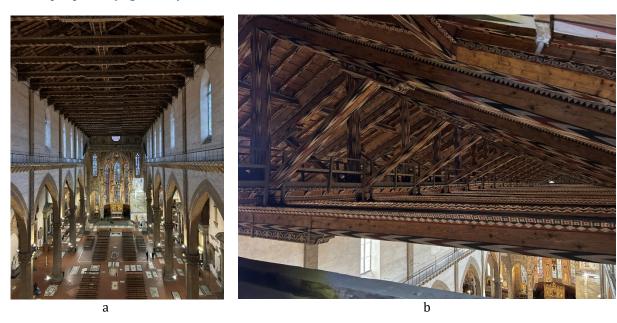
Figure 26. Basilica di Santa Croce (a) the central nave; (b) detail of the timber structure of the central nave

The roof structure, as in several ancient Franciscan churches, consists of exposed timber framing, with the exception of the chapels in the transept, which are vaulted. The central nave has a double-pitched roof, supported by a primary framework of 31 trusses that carry the secondary framework composed of purlins, three for each slope and two at the ridge (Figure 5b). The purlins in turn support joists

arranged parallel to the slope direction, on which the wooden boarding rests, completed by battens positioned where the boards meet side by side. Resting on the truss tie beams, centrally positioned, is a walkway that runs along the entire length of the basilica. Decorative geometric motifs in white, black, and red adorn the entire wooden roof structure and the walkway. Additional wooden elements, such as closure boards, frames, and cover battens, complete the structure, serving both functional and decorative purposes (Figure 6b).

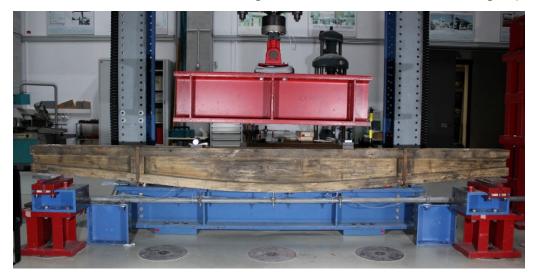
Figure 4. Bending tests

A total of 13 beams were available to determine the bending strength and the flexural elastic modulus. As already described, the different arrangement of the headbands in the first and second/third central purlin position results in two different support widths for the S 1 and S 2 series. The tests were carried out in accordance with DIN EN 408. [19] To measure the deflection of the beam during the test, displacement transducers were attached to the lower chord in the area of the supports, load application points and in the middle of the beam. In order to determine the global flexural modulus of elasticity according to DIN EN 408, the curve portion of the force-displacement diagram in the range between  $0.1^*$  Fmax,est and 0.4Fmax,est must be subjected to a regression analysis, whereby the correlation coefficient must be greater than 0.99. This condition was met in all bending tests carried out. Thus, the modulus of elasticity for all beams was determined between an applied load of F  $\approx 7.8$  kN to F  $\approx 18.2$  kN,

which at an assumed maximum load of FEst = 52.00 kN corresponds to a factor of  $0.15^*$  Fmax,est and  $0.35^*$  Fmax,est . The assumed maximum load fixed was calculated beforehand and adjusted based on preliminary tests. According to DIN EN 384, there is a modulus of elasticity of E[20]m,0,mean = 6,201.97 N/mm² and a 5% quantile of Em,0,k = 4,155.31 N/mm². The flexural strength was determined based on Section 19 of DIN EN 408 [19]. The bending strength to be calculated corresponds to the maximum bending stress in the beam at the time of failure. Due to the existing beam geometry and load situation in the 4-point bending test, the maximum bending stress does not occur in the middle of the beam, but in the area of the load application points. Here, the bending moment reaches its maximum value, whereas the resistance moment to bending is lower than in the middle of the beam. The characteristic value of the bending strength according to DIN EN 14358 f is[21]m,k = 3.96 N/mm². The determined bending strengths are to be regarded as lower than the actual bending strengths of the beams, since all of them failed in the 4-point bending test due to a failure due to shear in the area of the supports and not due to a bending fracture. This means that at the time of failure, it was not the bending strength of the beams that was exceeded, but the shear strength of the timbers used or that of the glue joints.

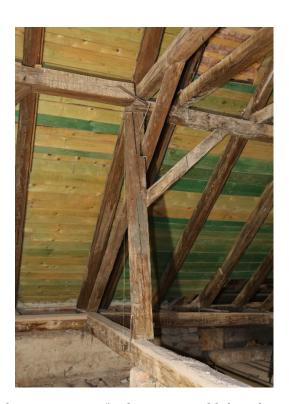
Figure 1 a)-c). Upper Town High School (origin of the Zagreb University, 1695). The sequence of failures begins with inadequately chosen joints: the strut is too shallowly lapped on the post without a dowel, there is a too-small dovetail lap with the collar, and the collar does not adequately "catch" the purlin on top of the post. These lead first to shear failures at the upper left dovetail lap joint, followed by rotation of the post due to shear failure in the collar. As the collar tie fails, a crack forms in the post, and the post inclines outward (upper left). The lower sketch shows the incorrect layout of the rafter on the collar, which subsequently fails in shear. The right sketch presents a better solution for queen-post structures. Red lines indicate possible remedial measures. Iron clamps are not sufficiently strong and secure for binding the elements, particularly not in softwoods.

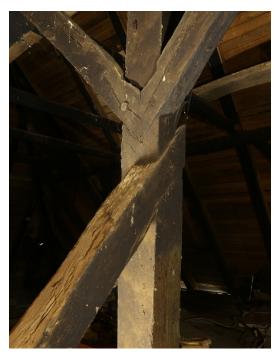
Figure 5 a) and b). Dovetail lap joints have too small an angle ( $<10^{\circ}$ ). When positioning two adjoining dovetail laps, poor alignment can cause wedge-like action, resulting in splitting of the post. To address this issue, refer to the suggested joint for this purpose located at the lower right.

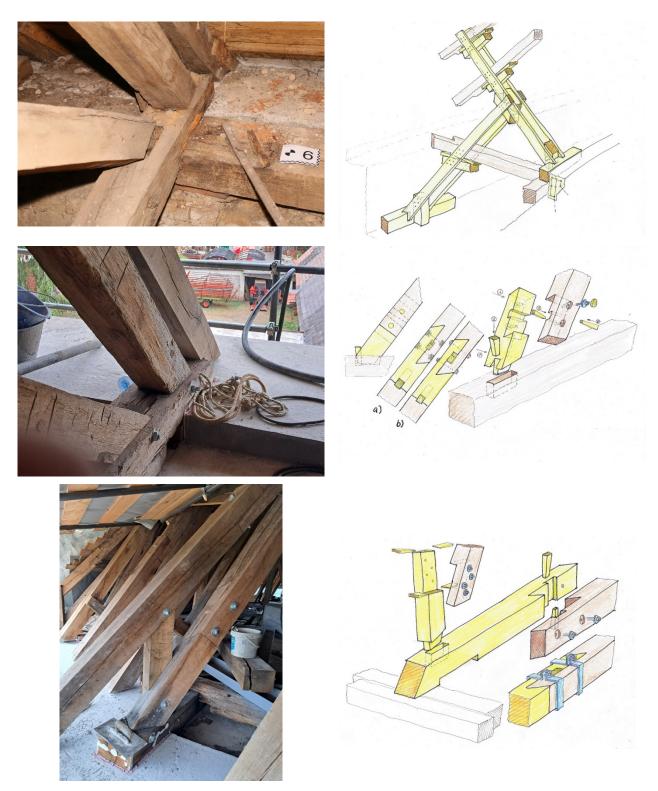
Figure 8 a) – f). Church of the Ascension of the Blessed Virgin Mary in Pokupsko (late 1700s). The Oakwood structure was damaged by distortion and opening of the joints and by biological damage (upper left). A reinforced concrete ring girder replaced wall plates, and rotten elements were partly replaced with prostheses. Tie beams and struts are now insulated in the concrete; the sprockets with birdmouth joint sit on the end of the beams (end grain opened for drying). Tenons and stop-splayed scarf joints with keys or wedges were used in reconstruction. These joints are fixed with threaded rods instead of the original wood pegs for reasons of better tightening and strength. Right column: Experts' sketches for the execution of joints and discussions with carpenters.

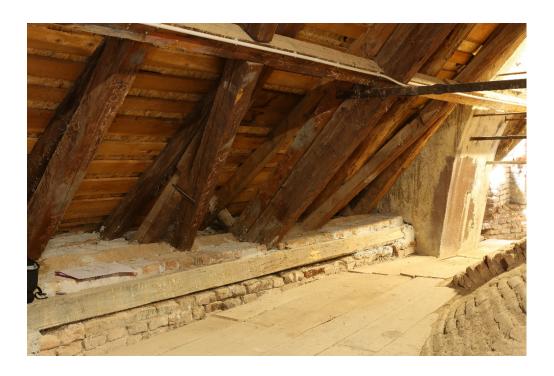
Figure 9 a) and b). Požega, Cathedral of St. Teresa of Ávila (1752). Due to the position of the dome, the roof was built as a reclining truss (in German "liegender Stuhl"). This popular structure relies heavily on load transfer to the wall supports, with tie beams installed only at the roof ends. Initially, the wall plate was laid in the brickwork; however, in later restorations, plaster or concrete was also used. This sequence exposed the wood at the supports to deleterious moisture risks and subsequent biological degradation. Once damage occurred, sketches of suggested replacements—including the installation of a concrete ring girder, a new ventilated and insulated wall plate, and prostheses for principal rafters and reclining struts—guided the engineer and carpenters in designing the final reconstruction.

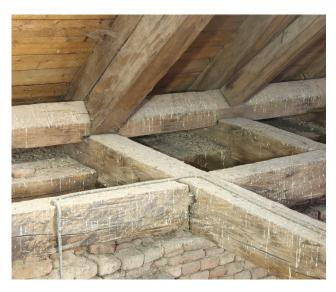
Figure 10 a) and b). Ivanić Grad, St. Peter the Apostle (1831). This is another example of a reclining truss. Initially, the double-wall plates exhibit biological damage, while the joints remain generally intact. The sketch on the right side shows a well-constructed assembly, with good execution of joints. The tie beams are correctly half-lap notched to wall plates, and the main beam is efficiently lapped with a crossed-tenon lap joint. As a result, even when wall plates are damaged, the joints and the rest of the structure remain stable. Such an assembly in oak wood, well-executed, presents a complex of very good stability in all directions; good craftsmanship ensures that there is no splitting or shear in the wood.

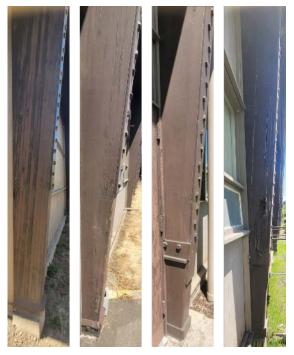
Figure 34. From left to right A13 with damaged coating, B8 with a wood prosthesis, D15 with a metal prosthesis and extended bracket, and D7 with notable brown rot in addition to a metal prosthesis and extended bracket.

Most glulam columns exhibited some degree of surface delamination. Discolouration, likely due to ageing and prolonged UV exposure, was also observed in several columns. Coating degradation ranged from minor to severe, with only a few cases showing extensive damage. In some instances, visible repairs had been made using either wood or metal components (Figure 5). One column, in particular, showed significant fungal decay and deep delamination (Figure 5); this element was flagged at multiple points throughout the assessment and should be prioritised for remediation.

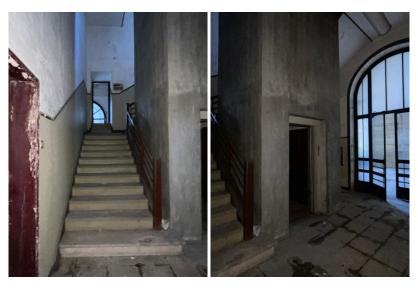
Figure 3. Reinforced concrete stairs and elevator shaft

In terms of its architecture, the building can be characterised as an example of the *Beaux Arts* style, stripped of ornamentation or with minimal decorative expression. The ornamental austerity observed in the treatment of the façades and the interior spaces is likely due to budget constraints and the functional nature of the program. The building's prolonged and uncertain construction process reflects limited resources, as evidenced by the project's incomplete execution. In addition to the original simplicity, there were several low-quality interventions throughout the building, including half-height brick walls, chipboard doors, exposed electrical and plumbing systems, styrofoam and plasterboard ceilings, unsightly light fittings with no concern for integration, etc. These changes contribute to a general sense of disorder and improvisation. As a result, the interior of the building lacks architectural or heritage value. This area previously accommodated various services of the University of Minho, featuring a functional character. Successive interventions conducted over time have gradually reduced architectural significance. In clear contrast to the private section, where the original architectural qualities have been respected, the public section underwent significant alterations, including the construction of a reinforced concrete staircase and an elevator shaft (see Figure 3).

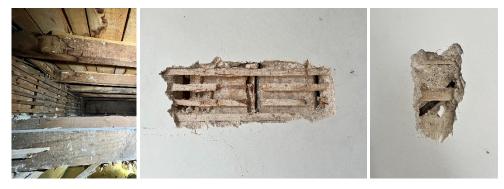
Figure 4. (a) Connection of floor beams with partition wall; (b) Partition wall with vertical planks; (c) Partition wall with diagonal planks

From a construction standpoint, the building adheres to the conventional architectural model of its era. The outer perimeter is delineated by load-bearing stone masonry walls, which are interconnected with similarly load-bearing, albeit narrower, stone walls. These walls are cross-linked to support the wooden structural elements, such as beams, upon which the parquet flooring and partition walls are constructed. Certain interior partition walls also serve a structural function. The roof structure, including the cupolas of the turrets, is composed of wood. The thickness of the granite masonry load-bearing walls ranges from 0.50 to 0.80 meters. In addition to the granite masonry walls, the majority of the interior walls are constructed using Scots Pine (*Pinus sylvestris*) boards, oriented either vertically or diagonally (Figure 4). While the granite masonry walls support the primary structure, some partition walls also function as intermediate supports for the timber beams.

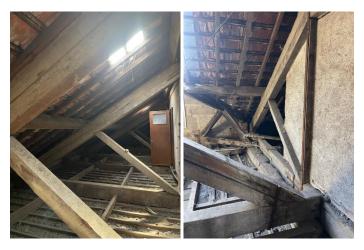
Figure 6. The roof structure is made out of wooden trusses with various geometries

The roof structure consists predominantly of wooden trusses, with different geometries, from simple to composite, varying according to the clear span to overcome and the function. The main trusses are composite, but there are also simple trusses (to support the corners), half trusses and others (see Figure 6).

Made of Scots Pine, the trusses feature traditional single-tooth and double-tooth carpentry joinery, usually reinforced by metal elements (squares, T-squares, crowbars, etc.). The trusses and granite masonry walls are supported by the usual elements of Maritime pine (*Pinus pinaster Ait.*) wood roofs: row, purlins, sticks and slats. The cross-sections and spacing of these elements may vary according to the area of the building, but correspond to typical construction practices and dimensions of the period. The state of conservation of the Castle Building's structure was evaluated from the accesses generated by the inspection windows. It was initially possible to carry out a visual inspection of the structural elements, identifying the main pathologies, their current state (active or inactive), the extent of the damage and its probable cause. In addition, semi-destructive tests were employed as complementary tools to the visual inspection: controlled perforation test (Resistograph), surface hardness test (Pilodyn), thermographic imaging and hygrometer (see Figure 7). Overall, the structure of the Castle Building remains in a relatively good state, considering its date of construction. The identified pathologies were consistent with the construction system and the building's age. However, certain areas showed critical degradation, particularly due to water infiltration caused by inadequate maintenance.

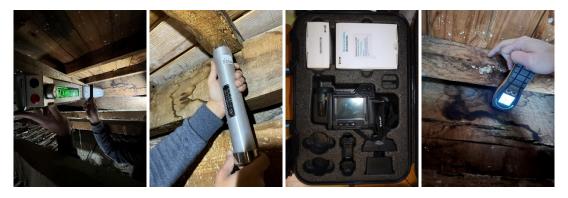
Figure 7. (a) Controlled perforation test; (b) Surface hardness test; (c) Thermographic camera; (d) Water content measurement with hygrometer

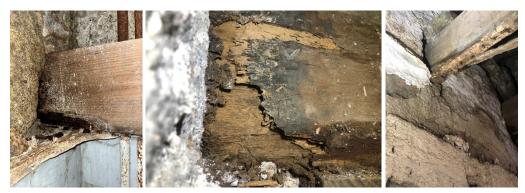
Figure 8. a) Beam of the chain that supports the ceiling of room S1.3 with damp and rot fungi; (b) Beam of the main beam of room S2.8 with rot fungi and beetle infestation; (c) Beam of the chain that supports the ceiling of room S2.2 with rot fungi and beetle infestation

Within the building, two areas were identified as being significantly compromised by advanced rot fungi, particularly in the encasement of wooden beams within masonry, as depicted in Figure 8. These pathologies remain active due to an unresolved source of moisture, which perpetually fosters conditions favourable for the proliferation of biological agents. In these affected areas, hygrometer measurements indicated a water content in the wood exceeding 30%. Conversely, in regions distant from the supports, the wood exhibited water content ranging from 10% to 12%, values that are consistent with the building's use and the prevailing environmental conditions (characterised by low relative humidity and high temperatures) at the time of measurement.

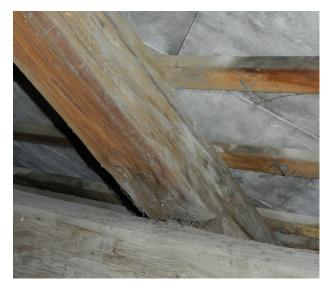
Figure 4. Loose connection of the rafter and lower purlin

In the next phase, based on the onsite wood preservation observations [14] (Fig. 2), we intuitively adjusted the properties of the connections: the tension or compression limits were determined, and the stiffnesses were adjusted according to the gaps or the damage of the connections (Fig. 3-4).

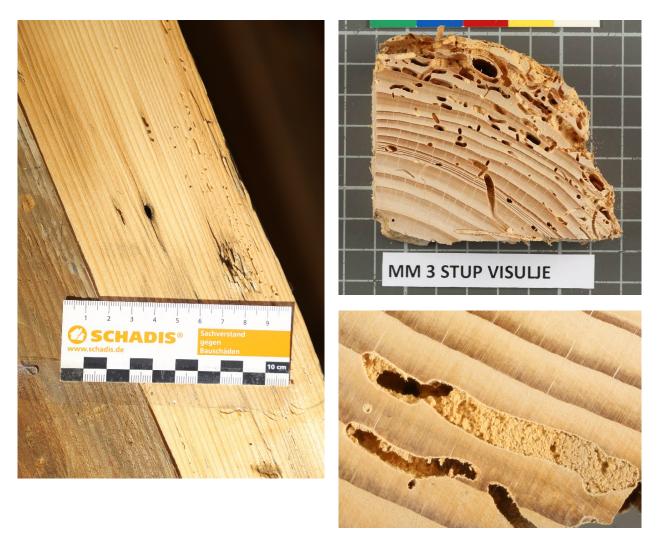
Figure 2. Left: half of the top surface of the beam was slightly planed to clean the dust and dirt. Damage can be seen only from sporadic exit holes, and only in sapwood-containing edges of the beam. Top right: polished cross-section of the edge of the beam containing a large amount of sapwood and larval tunnels. Bottom right: enlarged larval tunnel filled with coarse excrement.

Damage along the beam edges is visible only at scattered exit holes. Beam edges contain sapwood, which is heavily infested by the house longhorn beetle Hylotrupes bajulus (elliptical larval tunnels, approximately  $3\times5-7$  mm, filled with coarse yellow frass). Circular larval tunnels of 1.0-1.5 mm, filled with white powdery frass, indicate infestation by Anobidae. The moisture content was below 16%, so such damage can be ignored, provided the wood remains dry and the roof is well-ventilated. Often, softwood beams were more severely damaged than oak beams; however, insect damage was mainly limited to the sapwood. In large-section elements, infestations may be ignored unless there is an ongoing risk of increased moisture (Fig. 2).

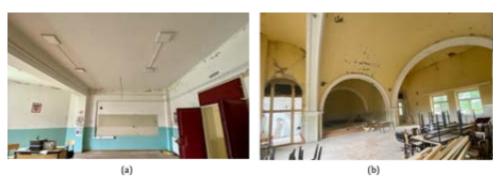
*Figure 2. The damaged interior: the south view of the ground floor(a) and west-north view of the first floor (b).*

The original structure has a laterally softer upper story, which results in large deformations and severe damage to walls and arches, as shown in Figure 2(b). The lower, stiffer story suffered shear damage mostly along the contacts of reinforced concrete and supporting masonry walls (Figure 2(a)). The observed consequences of the earthquake are well simulated by the herein presented 3Muri assessment. Therefore, it can be presumed that the computation model and method of structural analysis give a realistic prediction of the strengthened structure's behaviour, as presented in Figures 6, 8, and 9. Figure 9 illustrates the distribution of damages at the significant damage (SD) limit state due to the action of the earthquake in the longitudinal (X) and transversal (Y) directions. The colour codification of damage levels is shown in Figure 8. More than half of the masonry piers and walls, as well

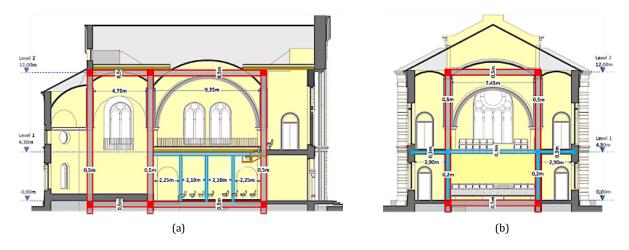
Figure 3. Concept of retrofitted and added structural elements: longitudinal (East-West) (a) and lateral (South-North) (b) cross-section of building.

The thickness of the ground-floor masonry walls is 61 and 46 cm, while the first-floor walls will be 46 and 30 cm thick. Conservators request the use of bricks of the same type as originally used. The percentage of reinforcement of the main inner frame columns is equal to 3.5% of their cross-sectional area. The percentage of reinforcement of the main inner frame beams is equal to 1.2% of their cross-sectional area.
